Description of document: National Nuclear Security Administration (NNSA) Post  
1980 Broken Arrow Nuclear Weapons Accident Issues

# BROKEN ARROW EXAMINATION

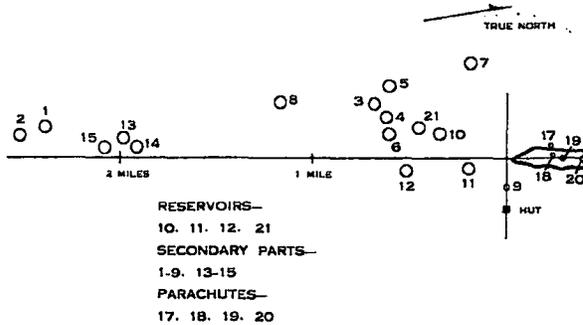
Figure 4—Location of recovered bomb components

- Bomb No. 1: Reservoir was found approximately 3,000 feet from the impact area. Parts of the secondary were found 1 mile and 2 miles south of the southern tip of the burn area.

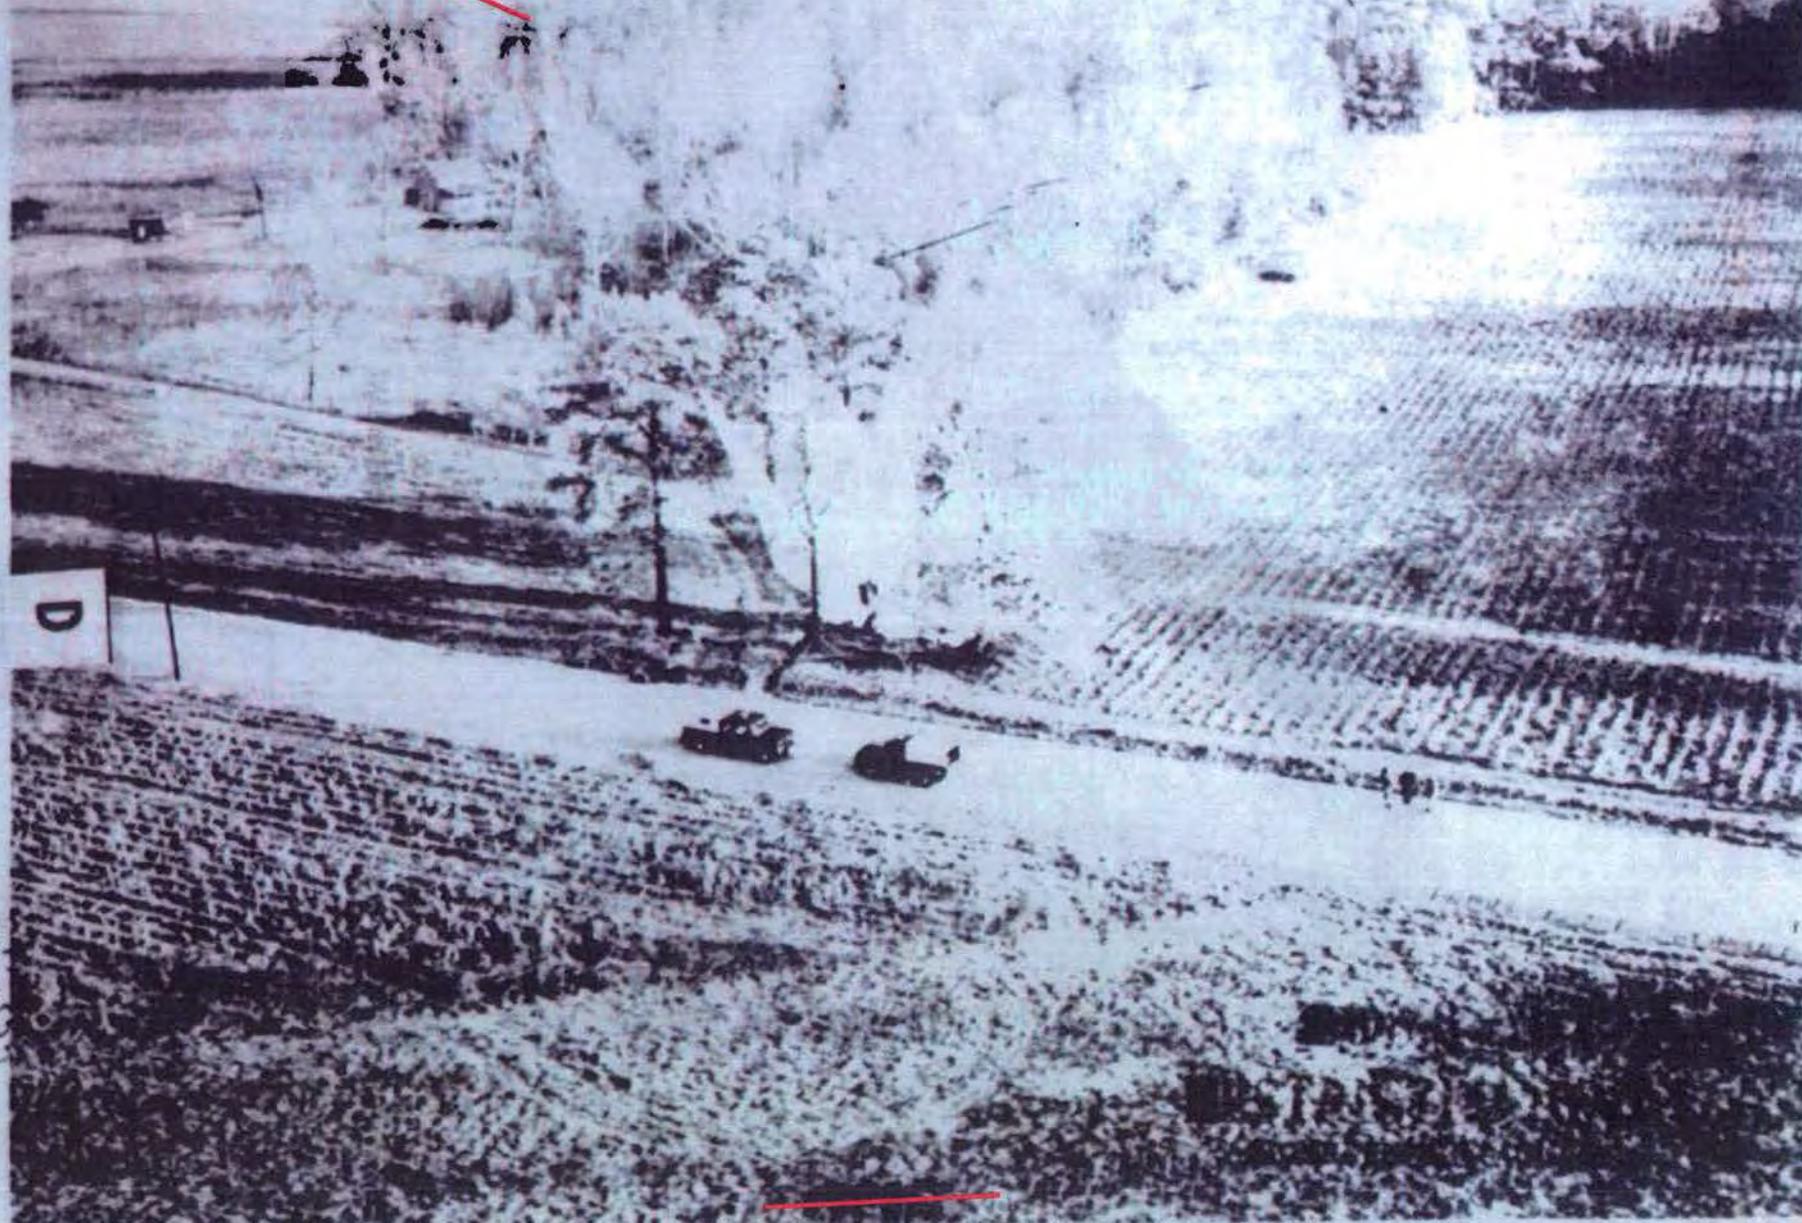
LOCATION OF AFT BOMB BAY WEAPON 1 MILE EAST OF BURNED WRECKAGE SITE.

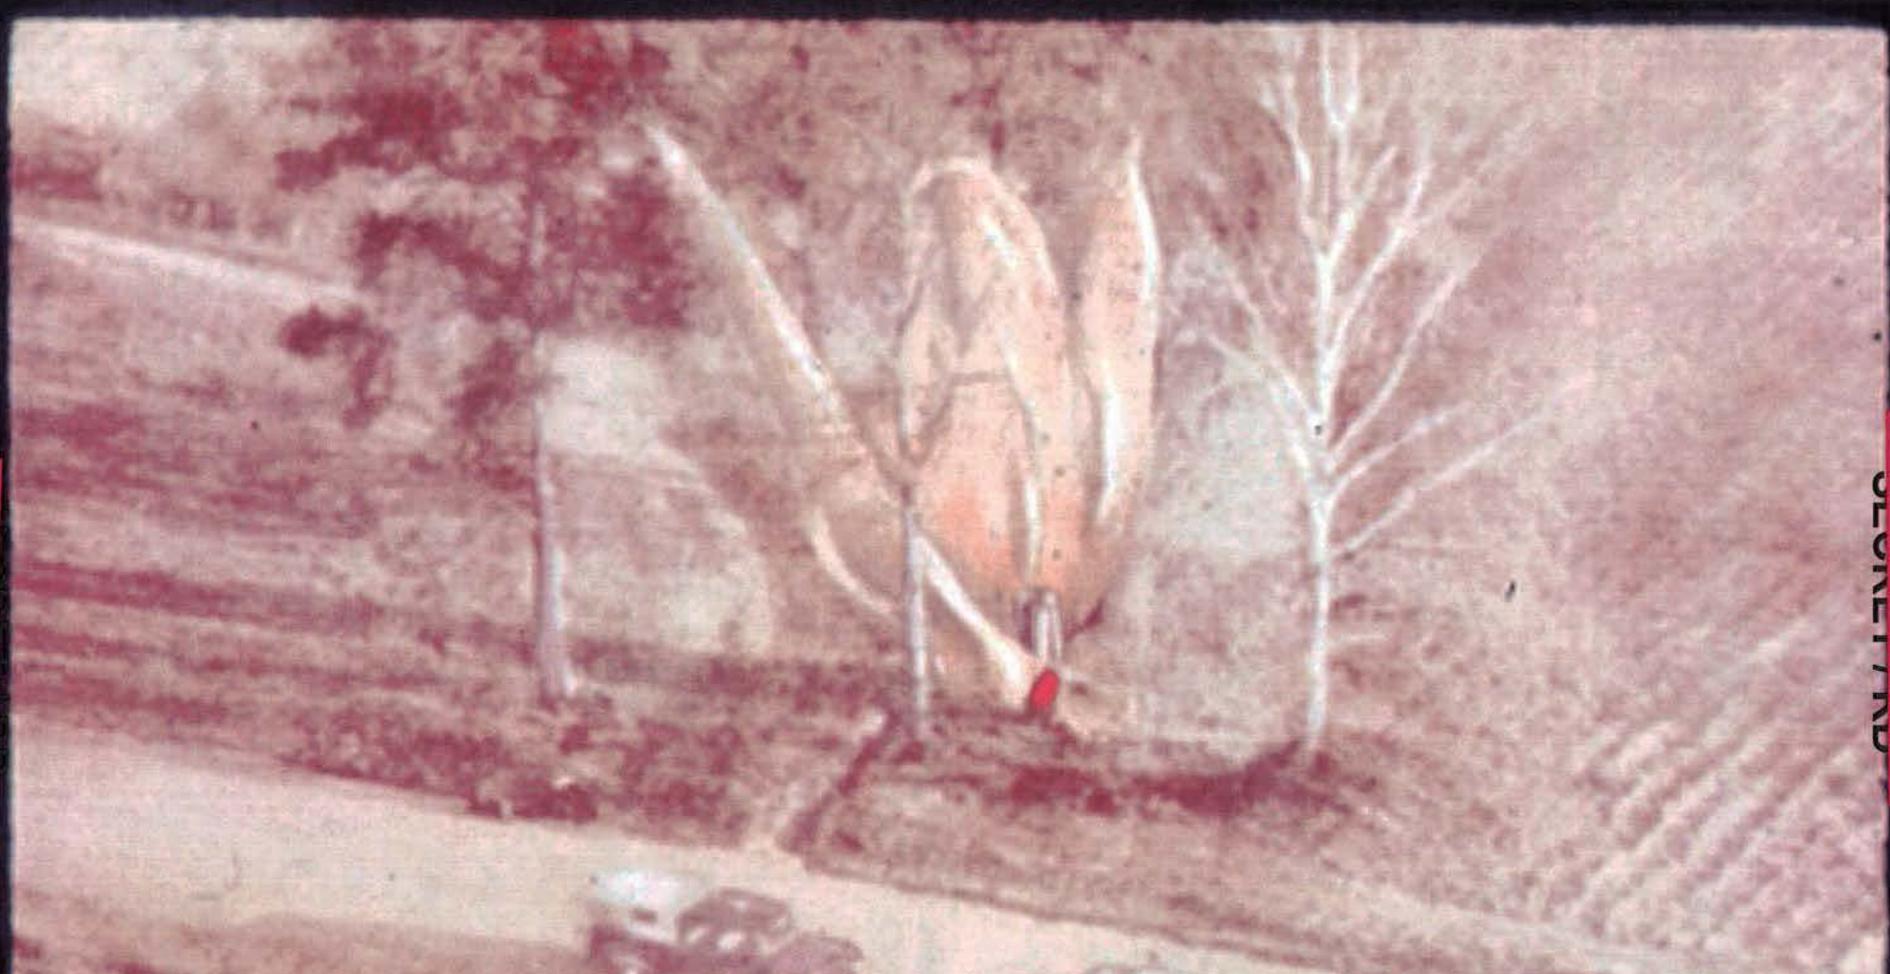
INCIDENT SITE (AERIAL VIEW) OF 1st WEAPON  
MK 39 MOD 2 SER. 1434909. NOTE 100 FT.  
PARACHUTE FULLY DEVELOPED

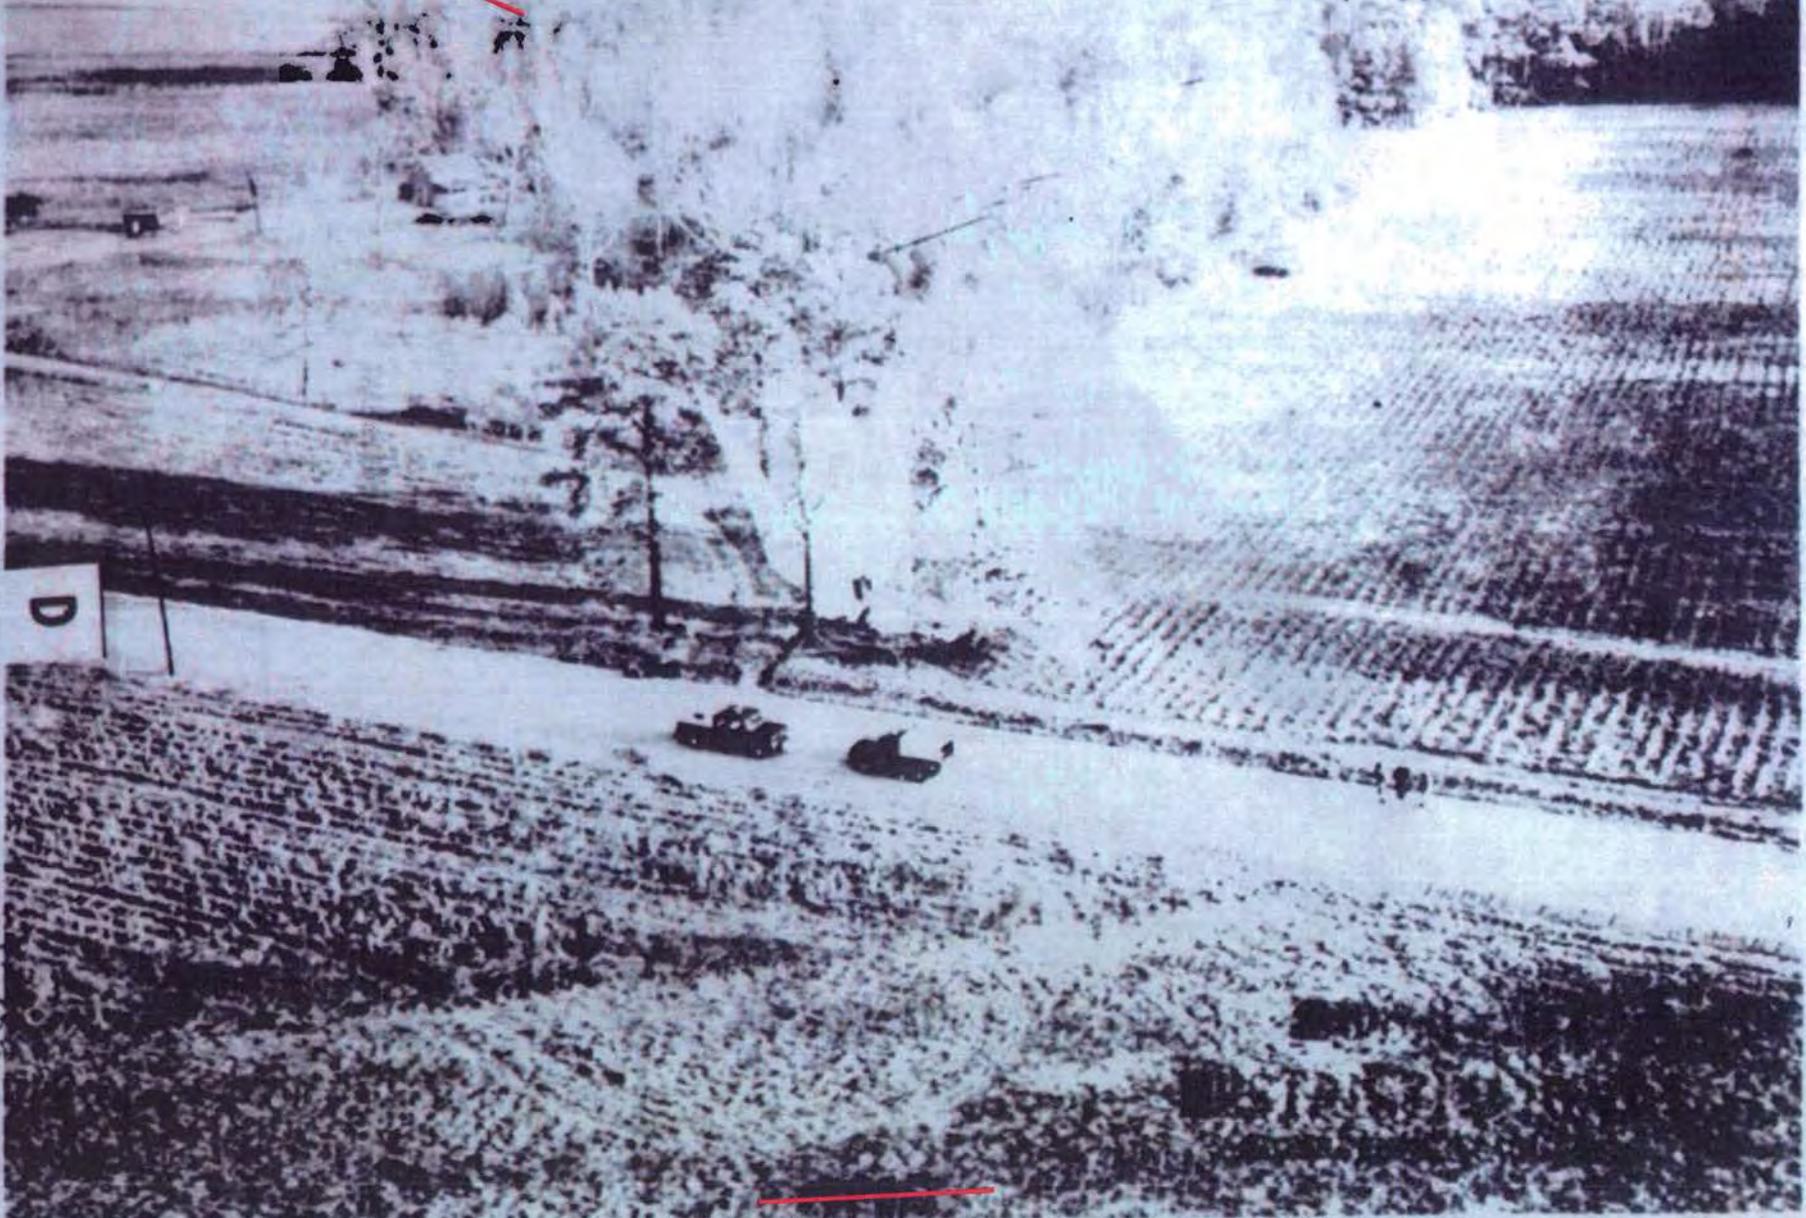
LOCATION OF AFT BOMB BAY WEAPON 1 MILE EAST OF BURNED WRECKAGE SITE.

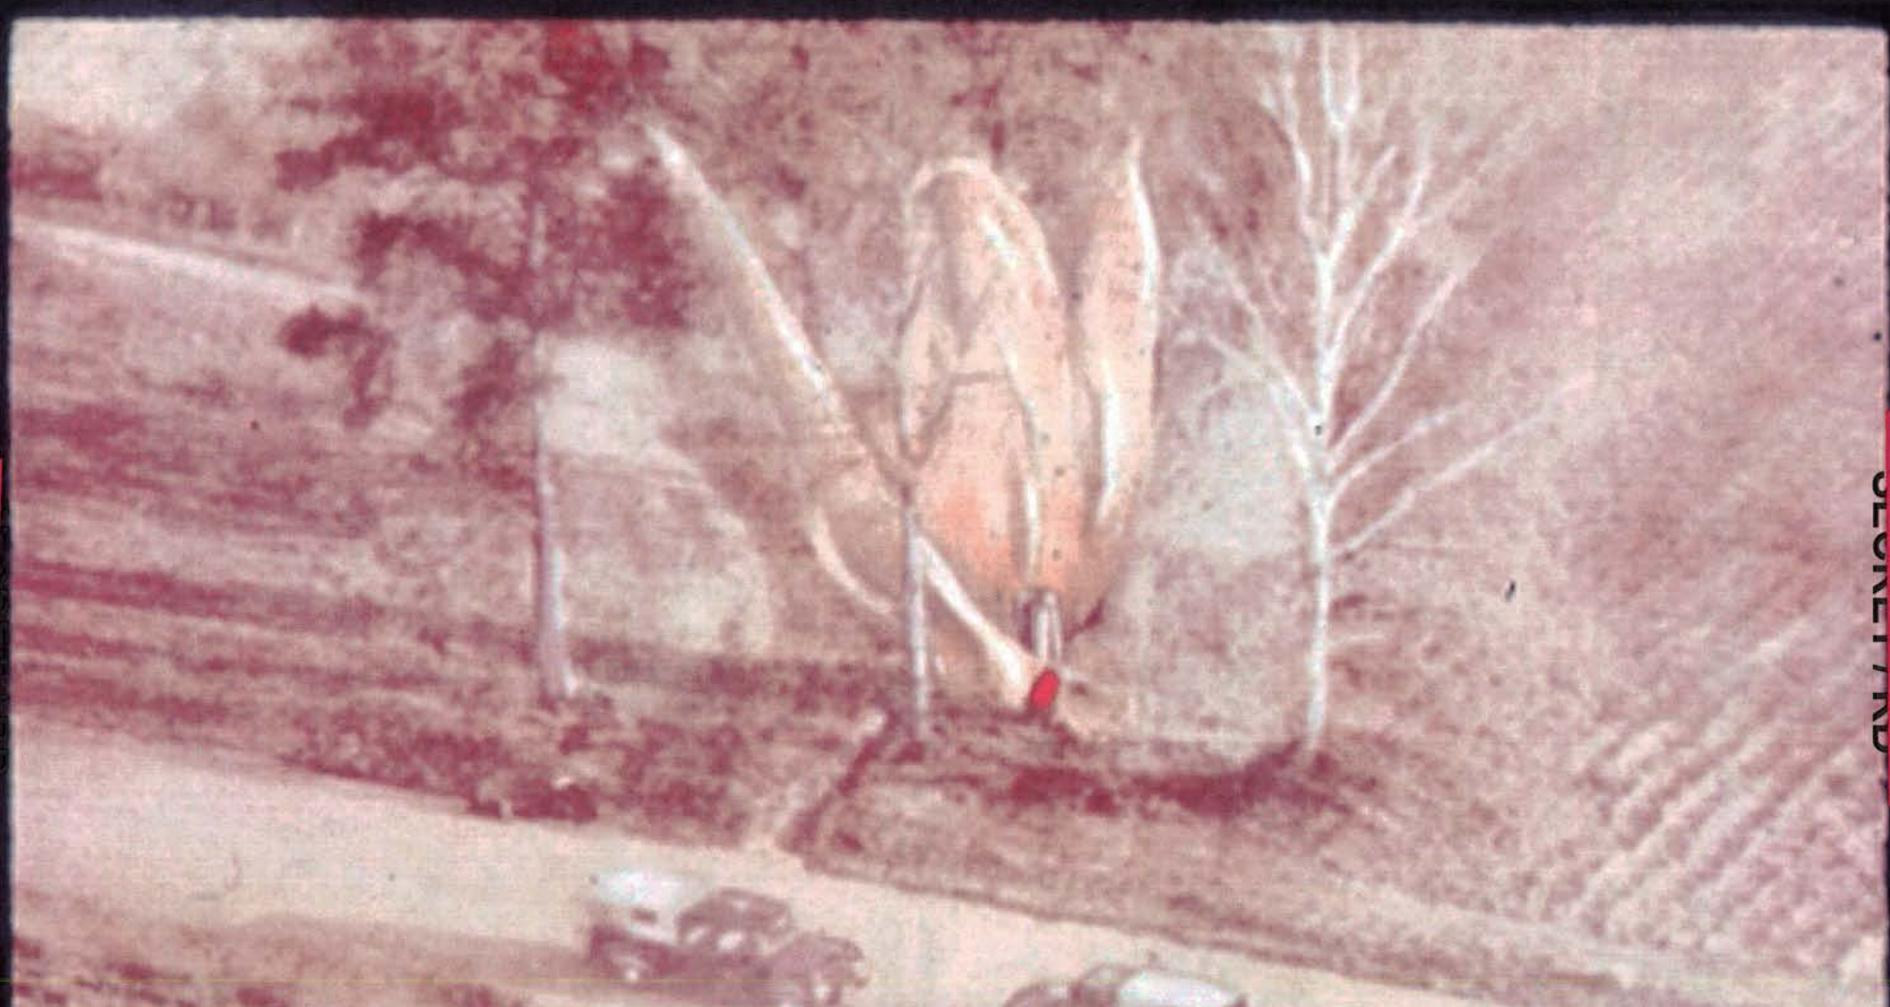
INCIDENT SITE (AERIAL VIEW) OF 1st WEAPON  
MK 39 MOD 2 SER. 1434909. NOTE 100 FT.  
PARACHUTE FULLY DEVELOPED
