Description of document: National Nuclear Security Administration (NNSA) Post  
1980 Broken Arrow Nuclear Weapons Accident Issues

# BROKEN ARROW EXAMINATION

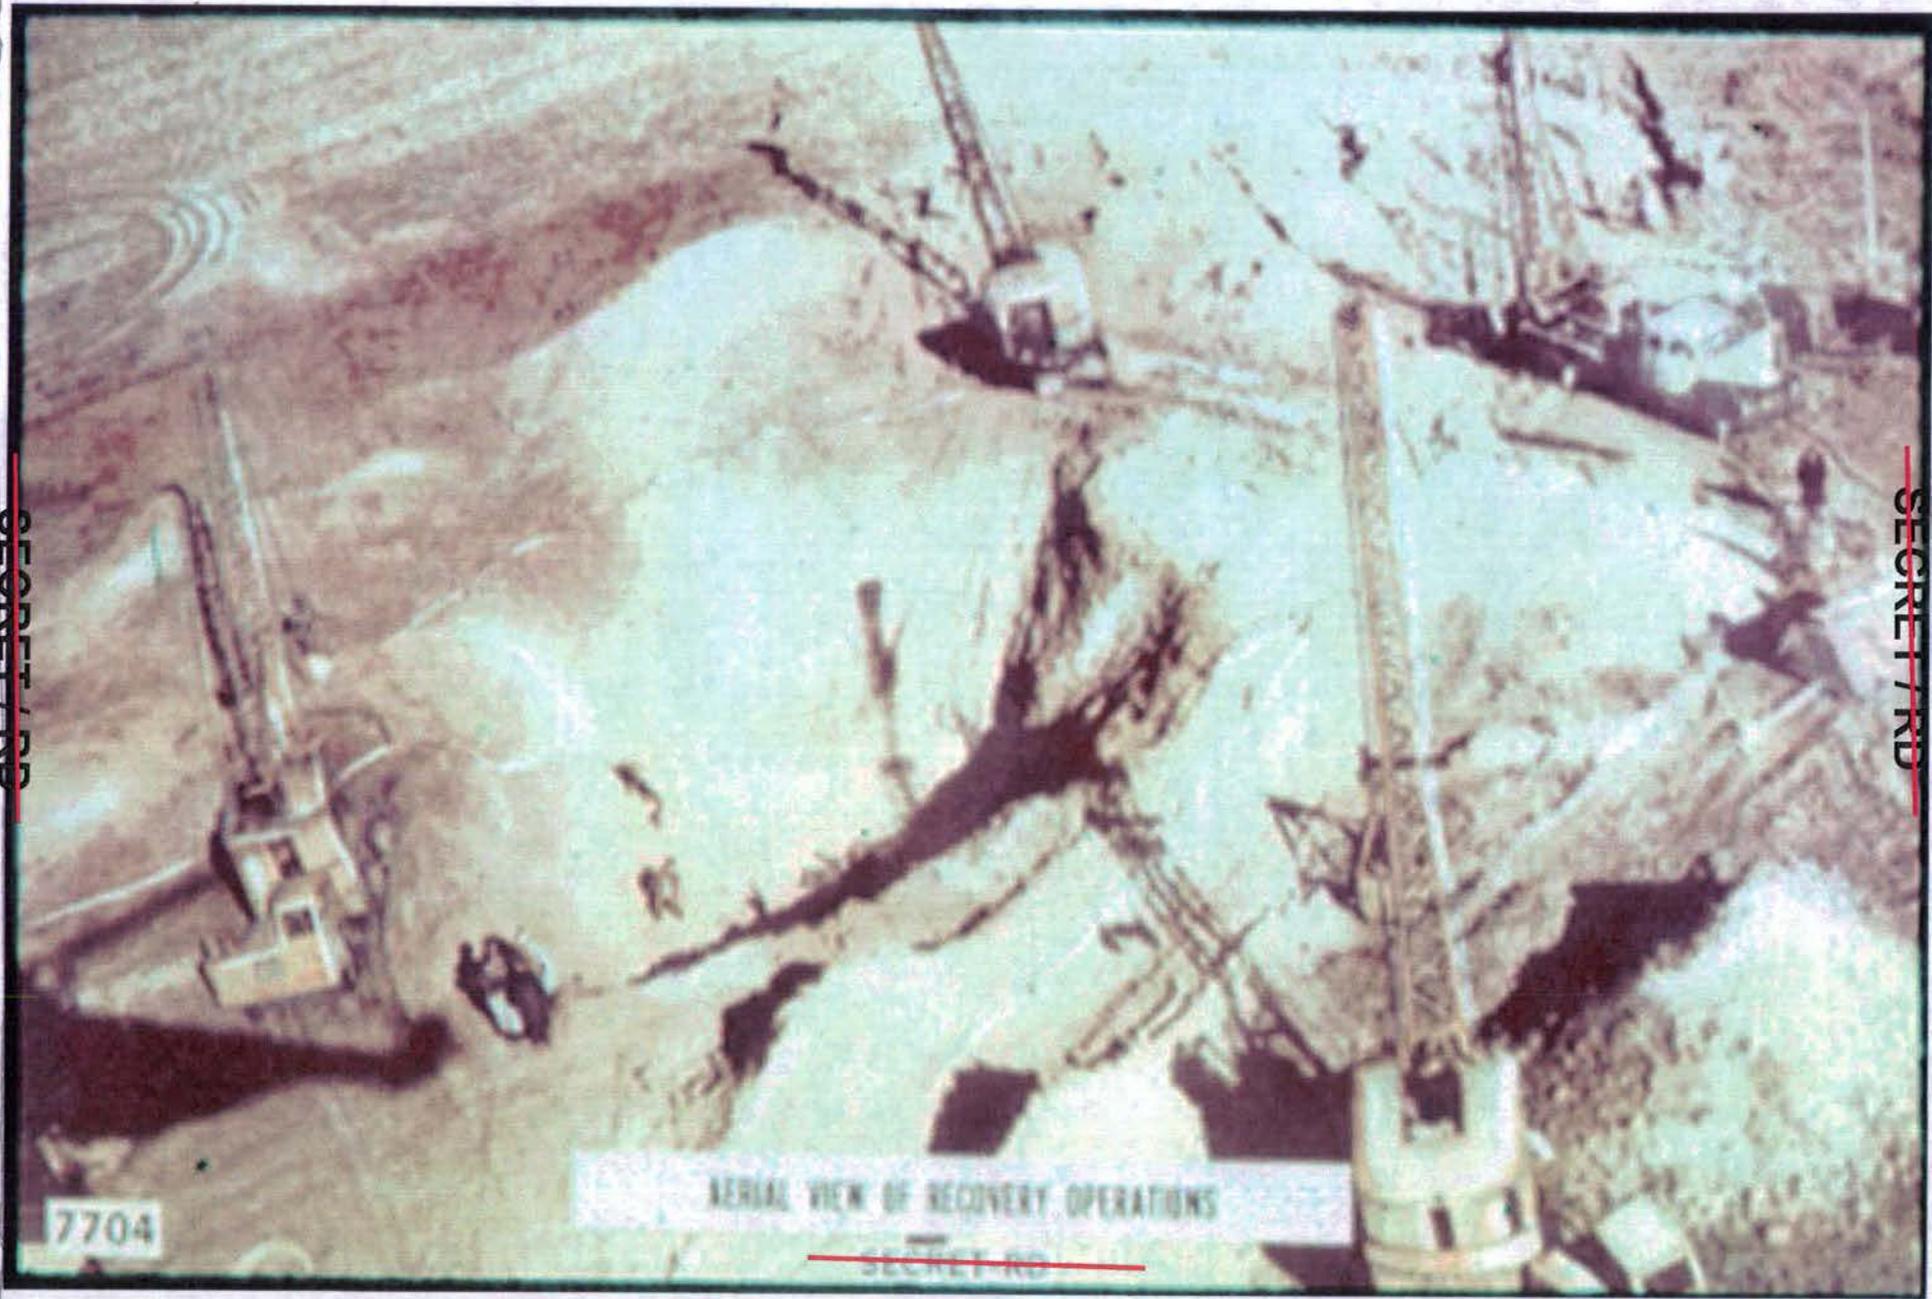
7704

AERIAL VIEW OF RECOVERY OPERATIONS

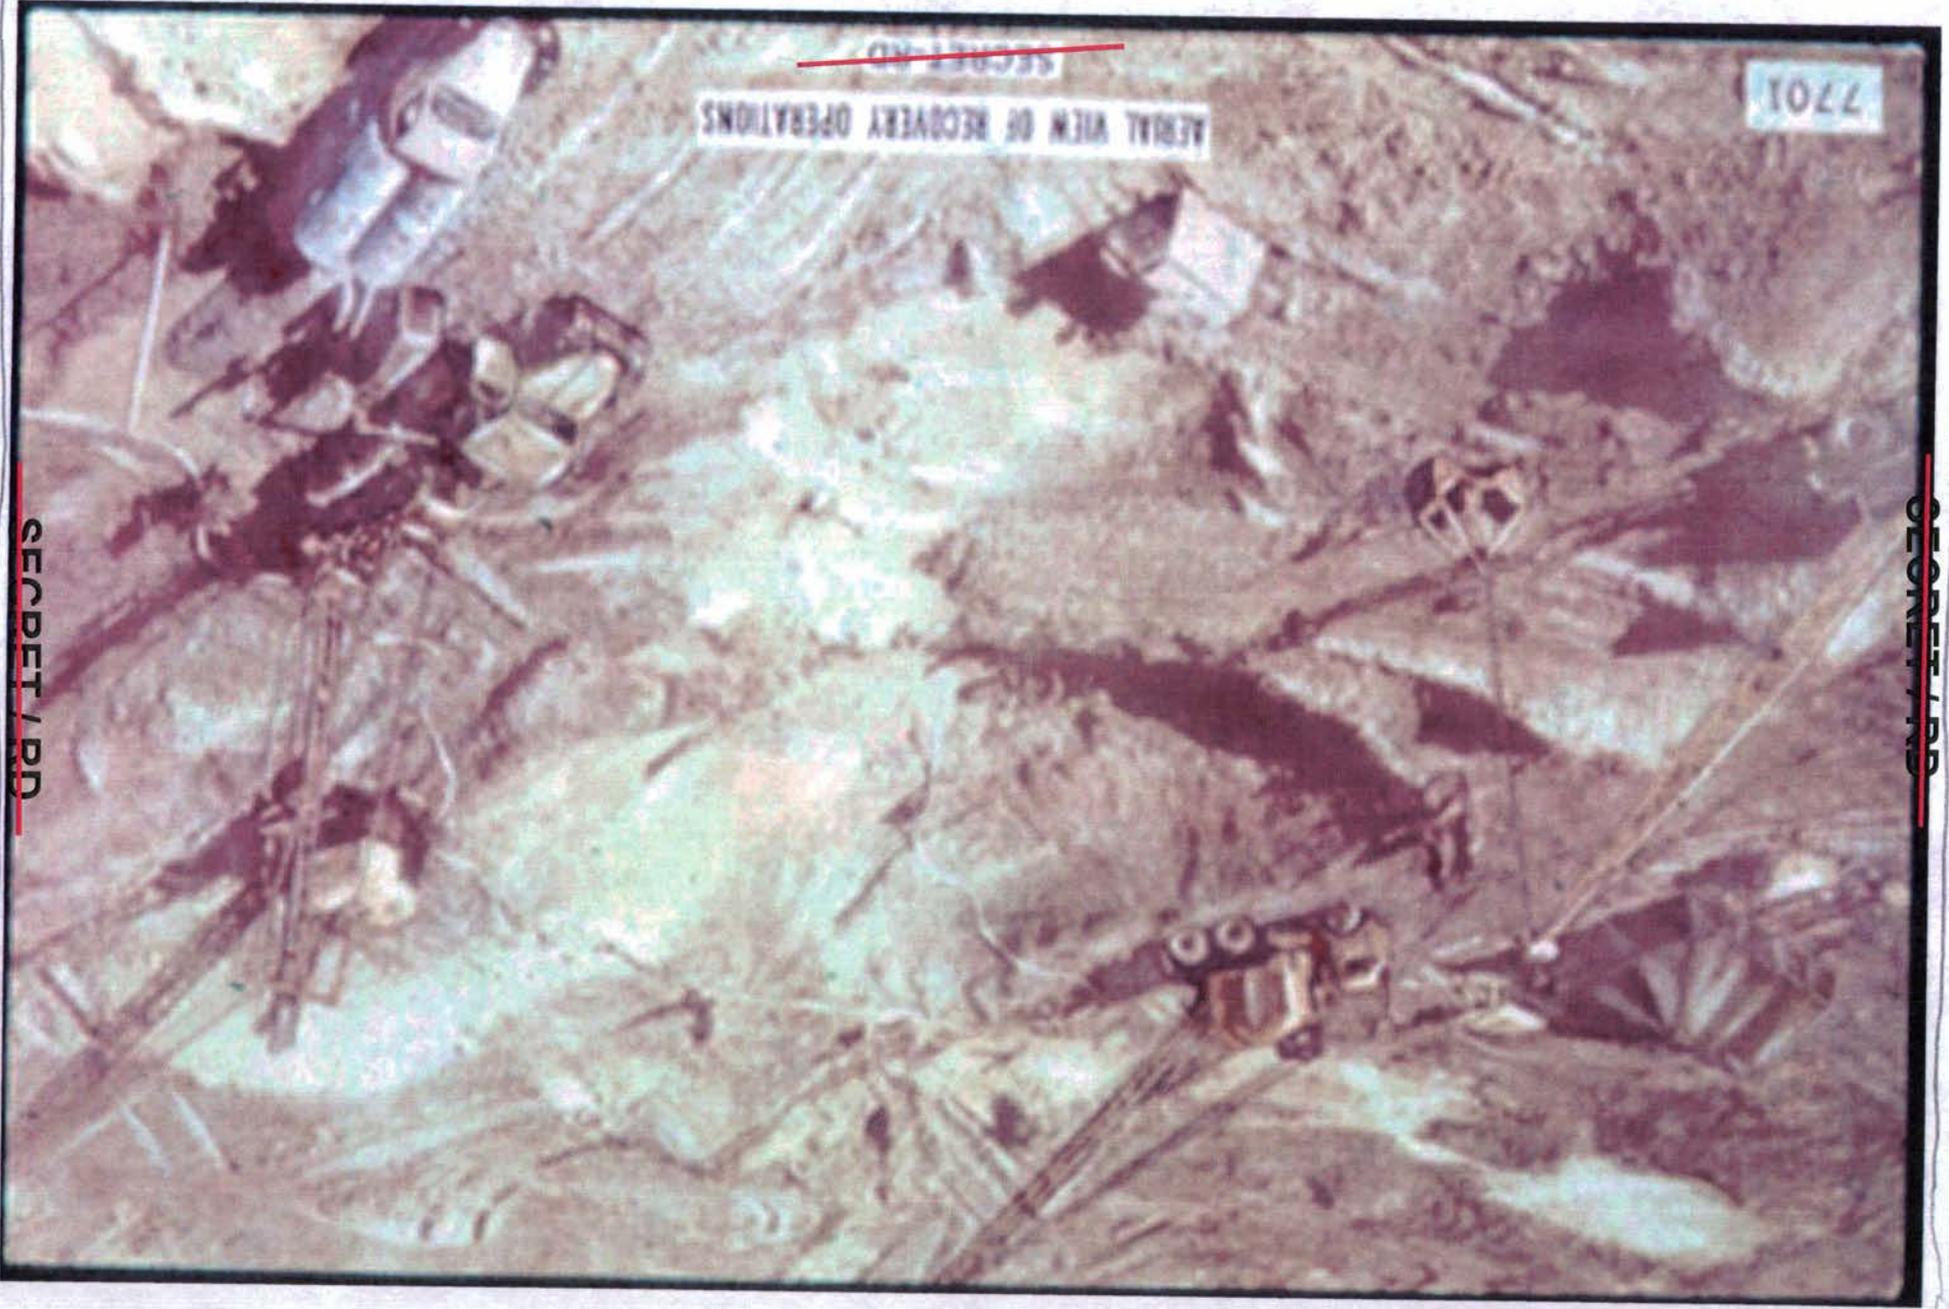
7701

AERIAL VIEW OF RECOVERY OPERATIONS

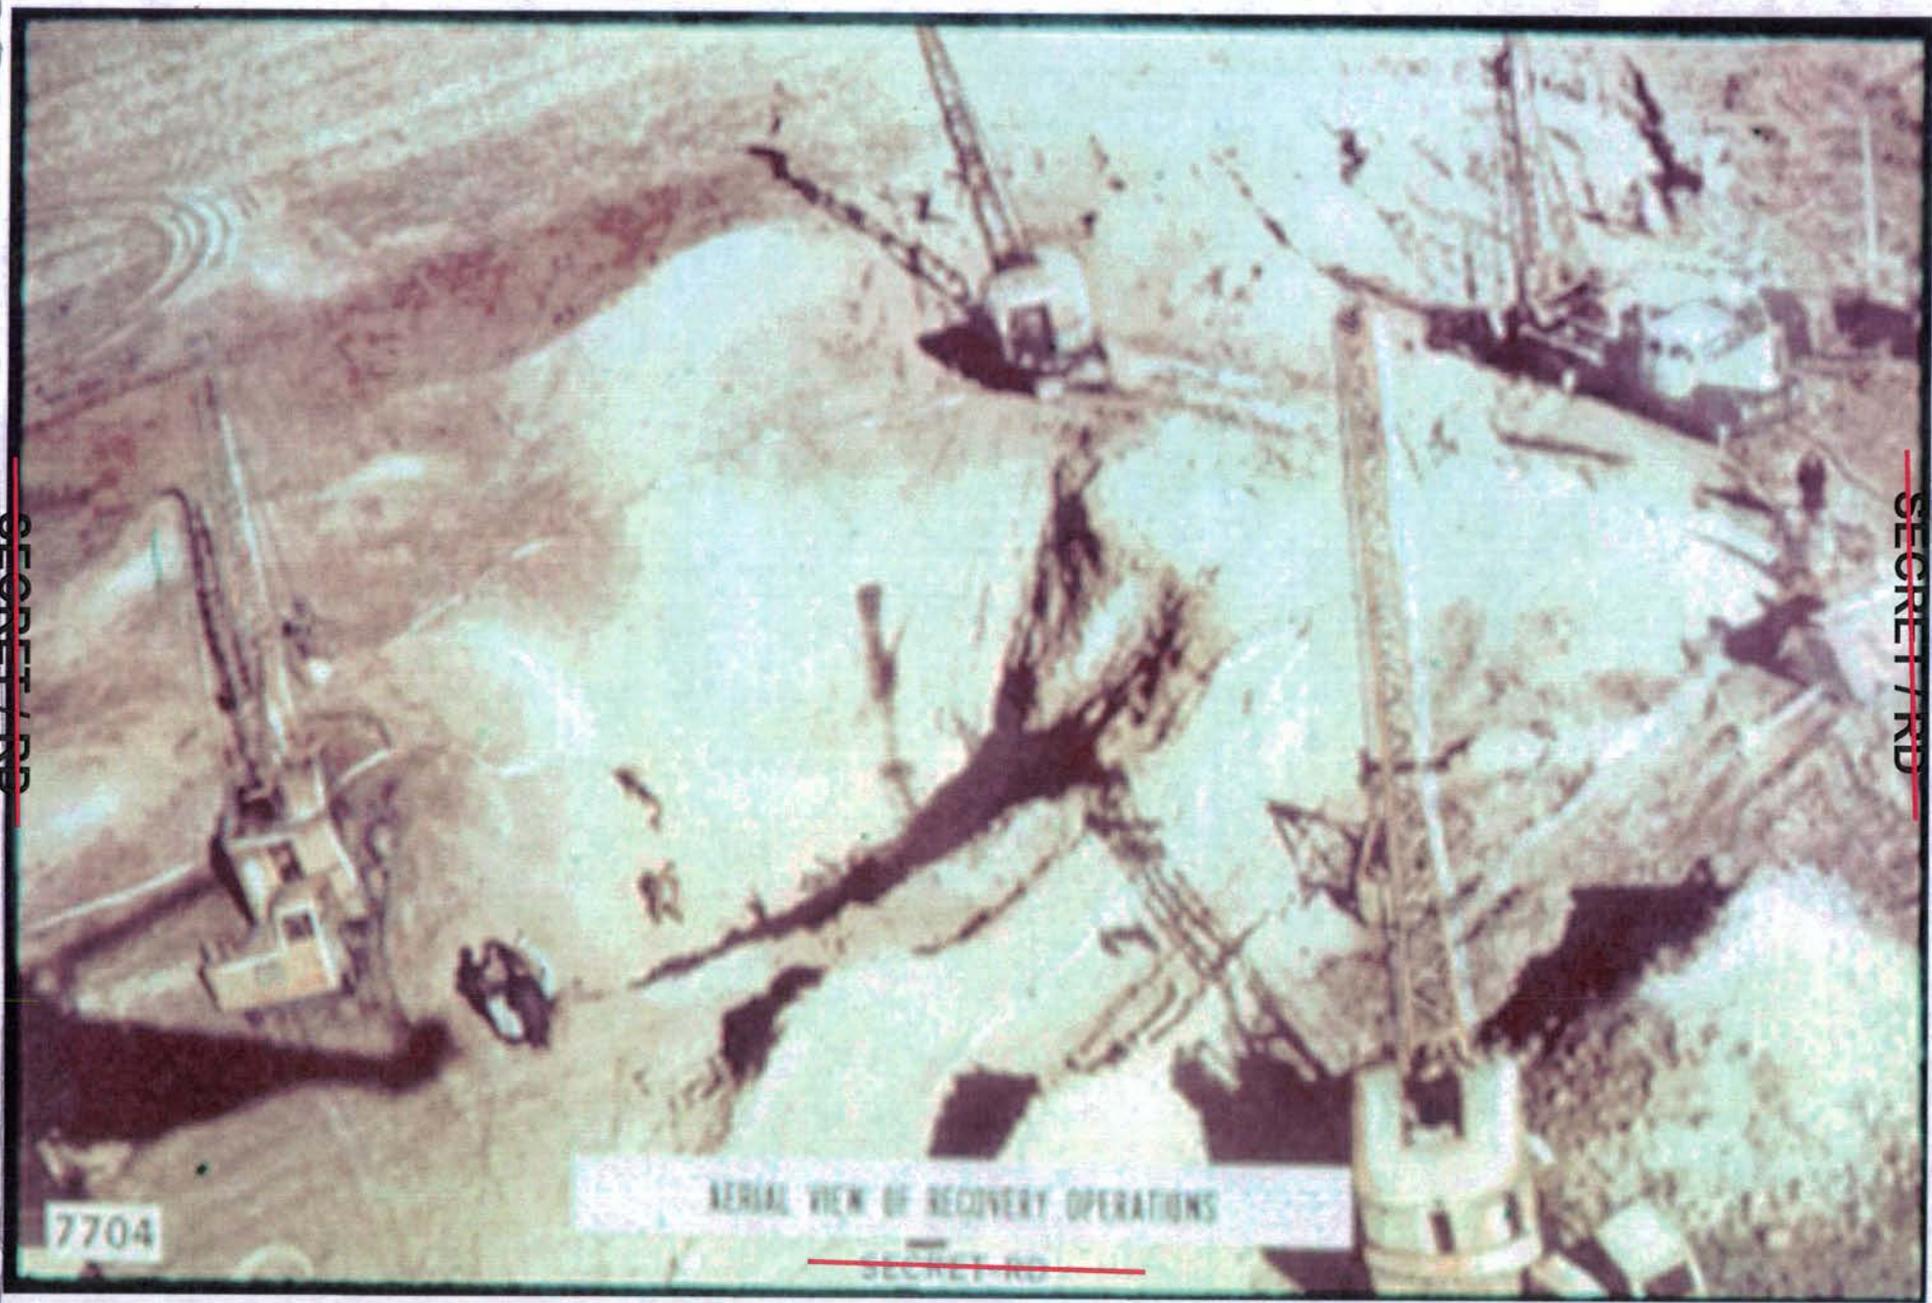
7704

AERIAL VIEW OF RECOVERY OPERATIONS
